Project: FSR 336 & FSR 343 2019 Road Improvement Project					
5 th or 6 th Hydrologic Unit Code (HUC): 1018001005					
Watershed name: Little Laramie River					
Name: S. Kuchenbecker	Date: 8/21/2019	□ Digital □ Film

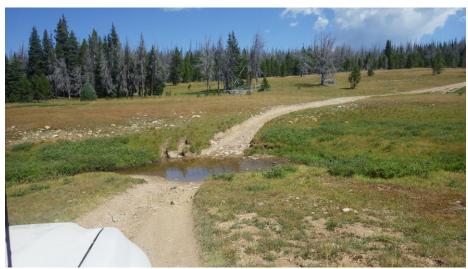
UTM NAD83 Zone 13		
No.	Digital #	Easting	Northing	Description
1	IMGP0486	393141	4571851	Fourlog Park stream crossing, no improvements needed, end of project scope on FSR 343
2	IMGP0487	392669	4571269	Braiding and rutting below main route
3	IMGP0488	392669	4571269	Main crossing with hardest surface
4	IMGP0489	392669	4571269	Original channel
5	IMGP0490	392669	4571269	View of multiple routes through wet area
6	IMGP0491	392669	4571269	Braiding and rutting above main route
7	IMGP0492	392669	4571269	Unvegetated area
8	IMGP0493	392669	4571269	Spring water above crossing

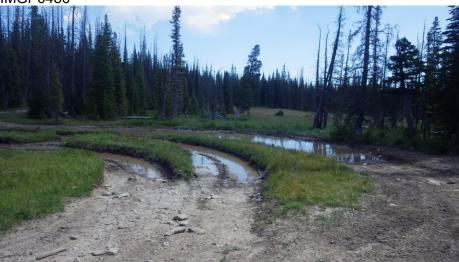
IMGP0487

Road damage in wet area between Fourlog and Nelson Parks. Area seeing heavy braiding and deep rutting. Route needs water bars installed and unauthorized braids destroyed on either side of this damaged area. Damaged area should be ripped, seeded, and re-contoured to promote restoration. Main route can be improved by adding fill material. Area needs buck and rail or other barriers to force use only on main route. I recommend the area to have a seasonal closure to prevent further damage once improvements are made.
